CHILTERN
CHALK STREAMS
PROJECT

Invitation to Tender

Scheme: River habitat restoration & barrier removal works to 1km of the Hughenden stream at Hughenden Manor

Works: **Design & build of river habitat improvement of the Hughenden stream at Hughenden Manor**

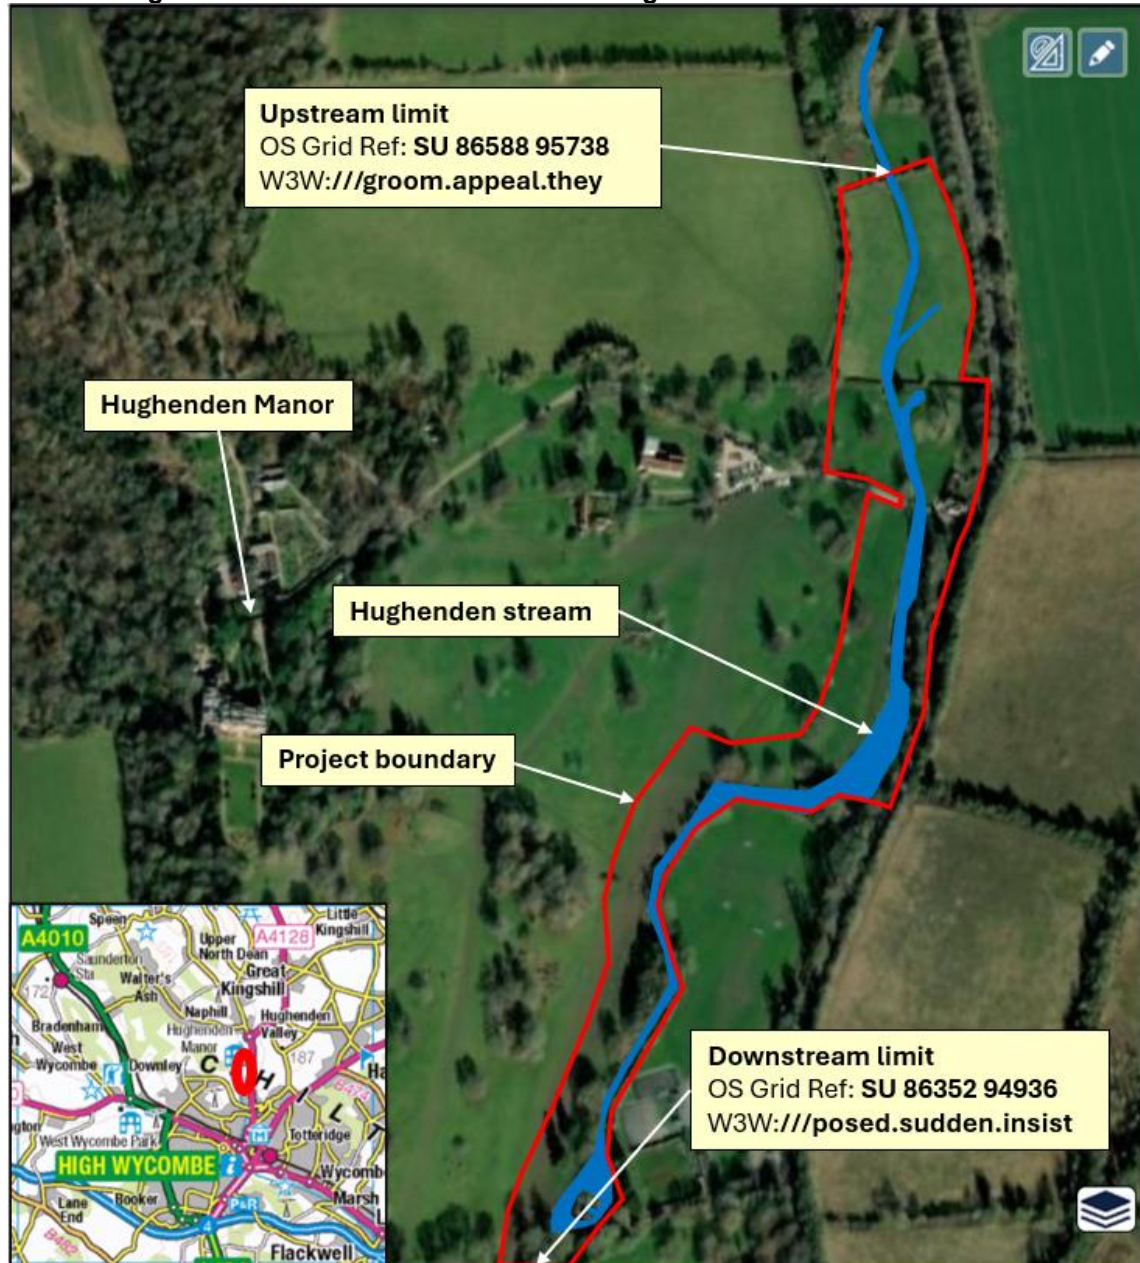
Figure 1 – Scheme area overview showing the locations of the activities

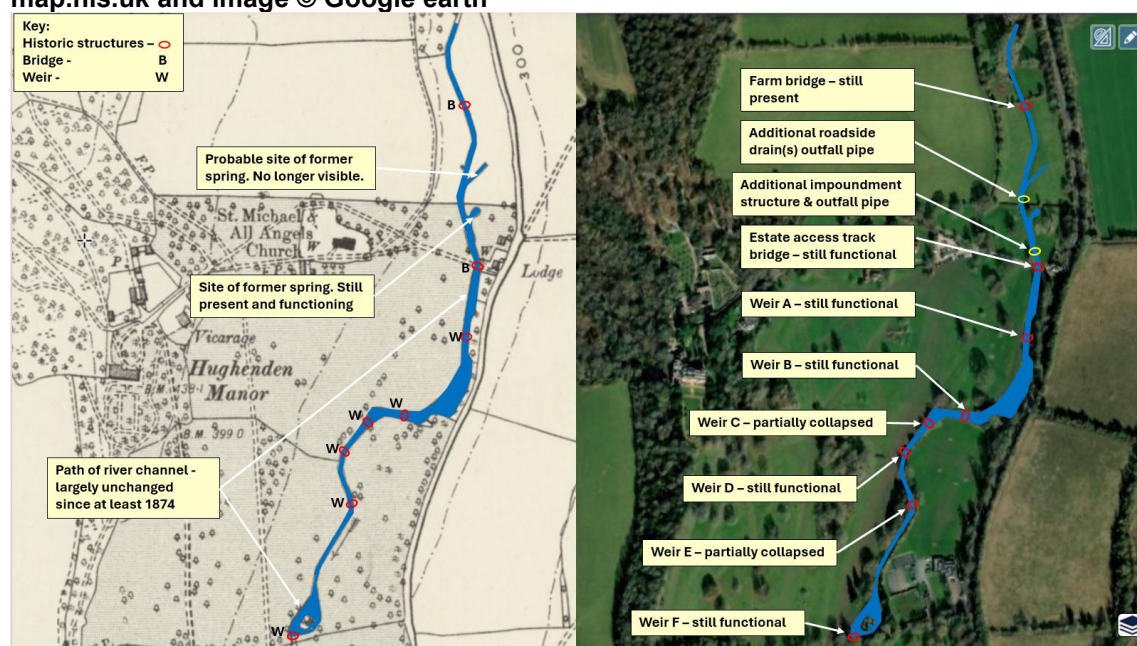
Fig. 3, below, shows a side by side comparison of how the project area looked in 1898 as compared with today. The location of each historic structure is provided together with a statement of the condition. One new impoundment structure which includes a culvert outfall pipe is additionally included.

Figure 3 - Historical comparison of Hughenden Manor in 1898 and today. Map © map.nls.uk and image © Google earth

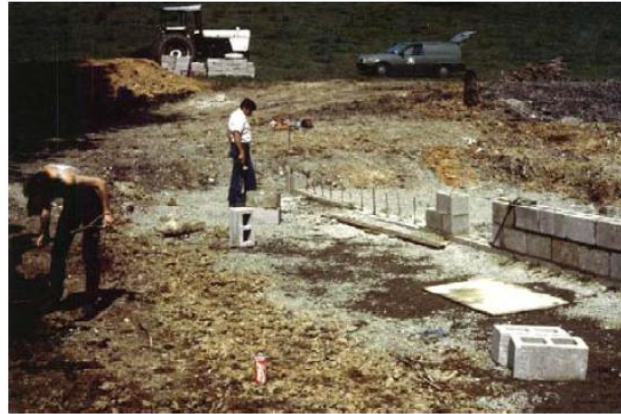
Figure 4 - Image showing the reconstruction of Weir F in the 1980s

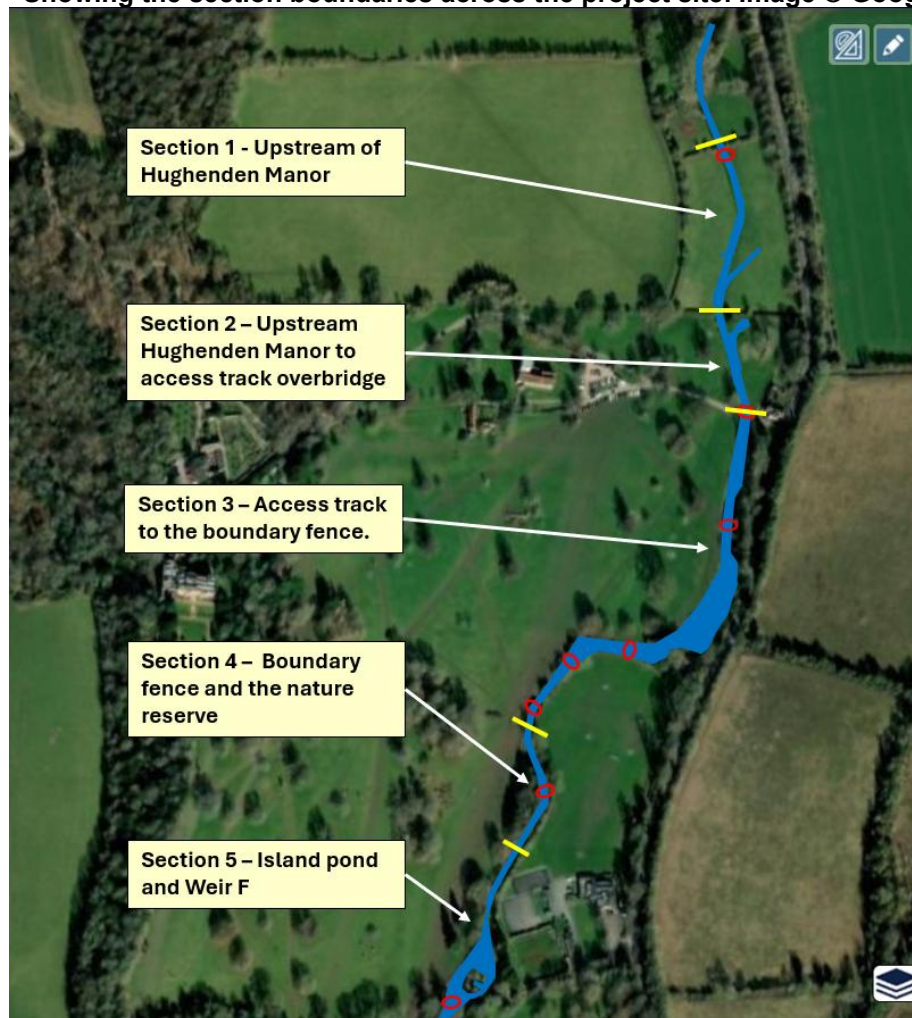
For convenience the site has been divided into a series of sub reaches as shown in fig. 5.

Figure 5 - Showing the section boundaries across the project site. Image © Google Earth

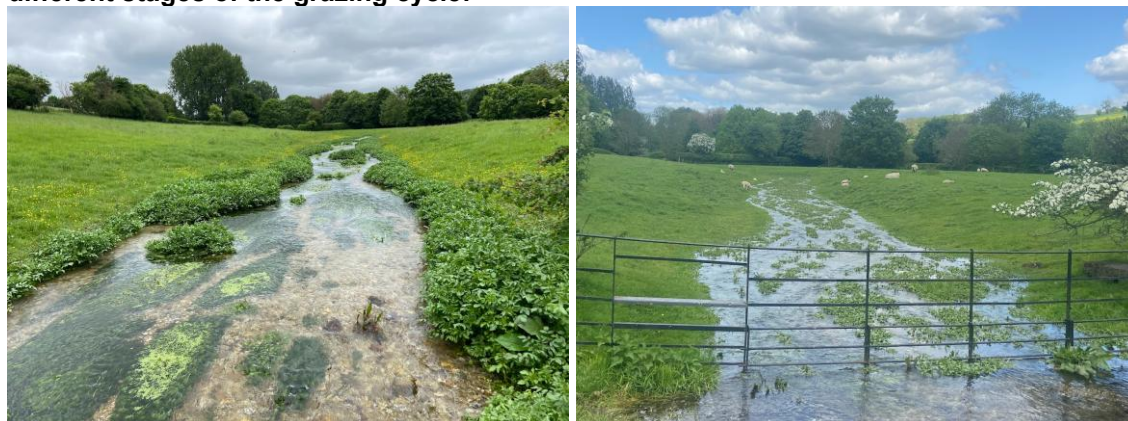
The channel is in reasonable condition with clean gravels and in-channel vegetation creating several flow pathways. Marginal vegetation is present although the zone for growth is narrow and there is no riparian buffer which reduces both the habitat mosaic complexity and the natural channel protection. The sward is kept close-cropped which reduces opportunities for insects and flowering plants.

Figure 6 - Views of the field, immediately upstream of Hughenden Manor, taken at different stages of the grazing cycle.

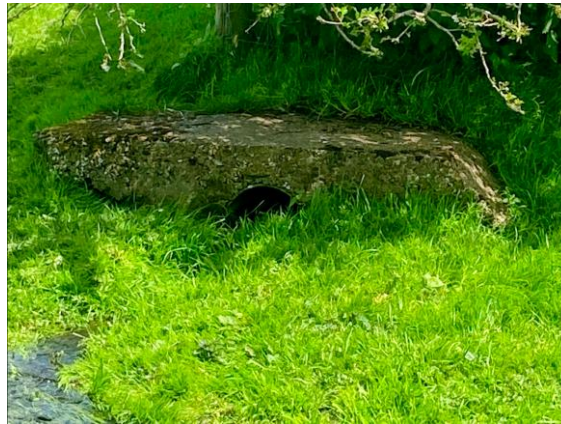
The southern boundary is marked by a mature mixed hedgerow with a 6m cut to allow the channel to flow through. Tucked under the end of the hedge on the true left bank is a service pipe outfall protruding from a concrete headwall - this is likely to be from the road drain at the eastern end of the hedge on Valley Road (SU 86663 95590). There are two further road drains on the same stretch of road, but it is not known whether these share the same outfall pipe or whether they have their own.

Figure 7 - Image showing the outfall pipe that may connect with the roadside gullies on Valley Road

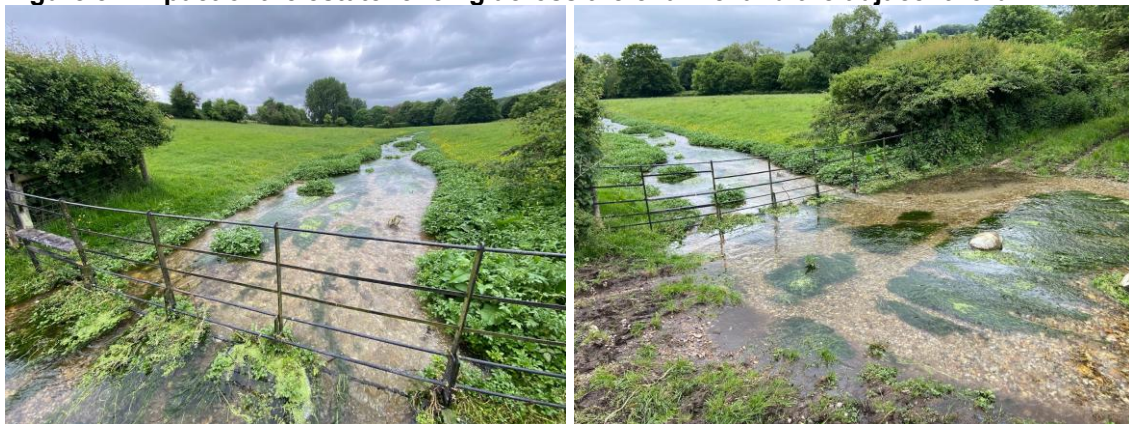
The upstream end of this 90m section is bordered by estate fencing which transects the channel where the hedgerow has been cut. This prevents stock from escaping but also traps detritus and dislodged vegetation brought down by the channel flows.

Figure 8 - Impact of the estate fencing across the channel and the adjacent ford

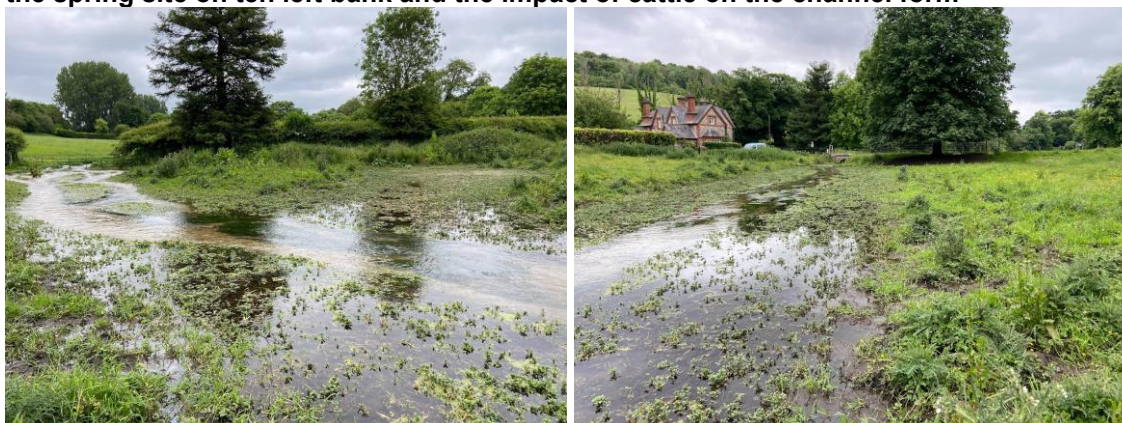
12m from the upstream fence line on the left bank is a diffuse seepage spring source that has been recorded on maps since at least 1846. Groundwater appearing here only has to travel 20m to join the main stream, but with the low gradient caused by dredging and additional impacts from poaching, it doesn't have enough energy to create chalk stream character and acts more as a source of sediment.

Figure 9 - Views looking upstream and downstream from the centre of the section. Note the spring site on the left bank and the impact of cattle on the channel form

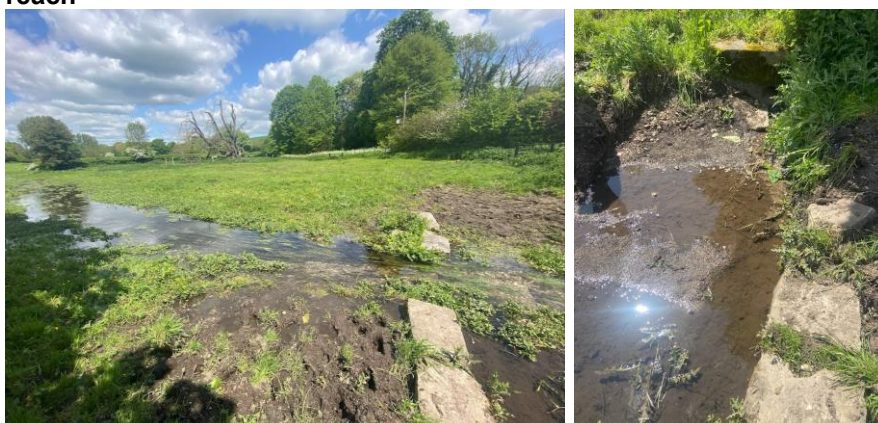
Figure 10 - The impoundment structure and associated outfall at the southern end of the reach

Consideration needs to be given to the outfall pipe which is immediately downstream of the impoundment structure, to reduce the sediment and other pollution that it delivers into the channel. With only 10m between the cattle-grid and the end of the outflow pipe, it may more practical to install SuDS ponds, swales or other flow interception system upslope of the cattle-grid and thereby prevent water from collecting in the first place. The remains of the impoundment structure can be retained as these are already narrowing the channel flows, but they could be obscured through covering with earth from the right bank or woody material.

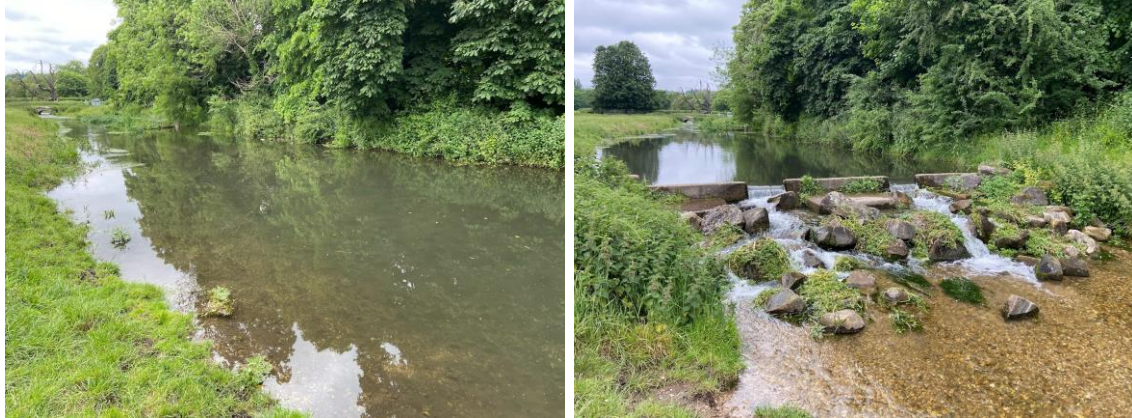
This section is 390m in length and includes three functional weirs and one partially removed weir, each with its own weir pool. Weir A has a drop of about 1.0m in total, Weir B around 0.5m, with another 0.5m lost in the channel sections in between.

Figure 11 - The first weir on the estate together with the pool it was designed to create

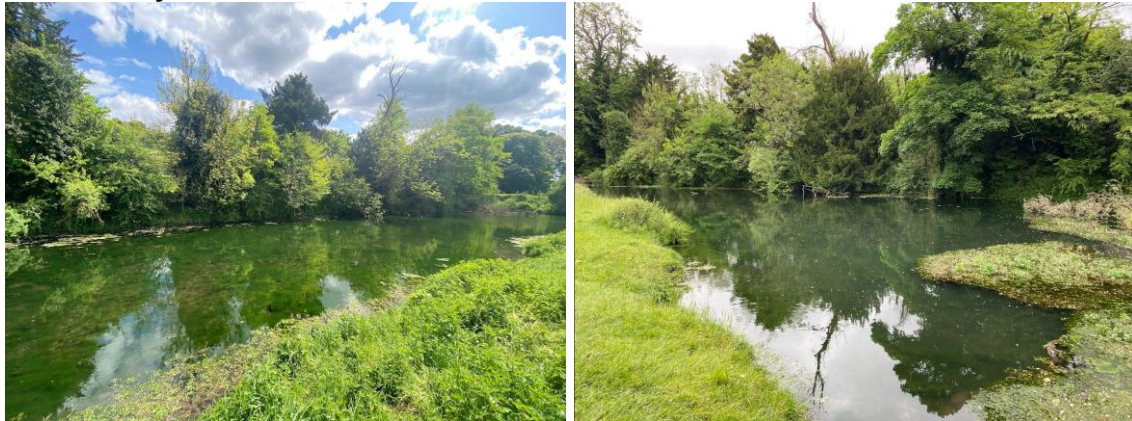
Weirs A and B are of concrete blockwork construction with sills of three different heights to provide passive flow management. The low sills on both weirs has a cumulative functional width of ~2m which ensures an even flow through the system, but this will be impacted through woody material and other floating debris being caught on the upstream sides of the slots. Although neither weir shows signs of being outflanked, both are in need of maintenance with signs of concrete degradation and water now passing below the structures.

Figure 12 - Below Weir A the channel is lost to a 2500 sqm lake which forms an arc on the SE boundary of the estate.

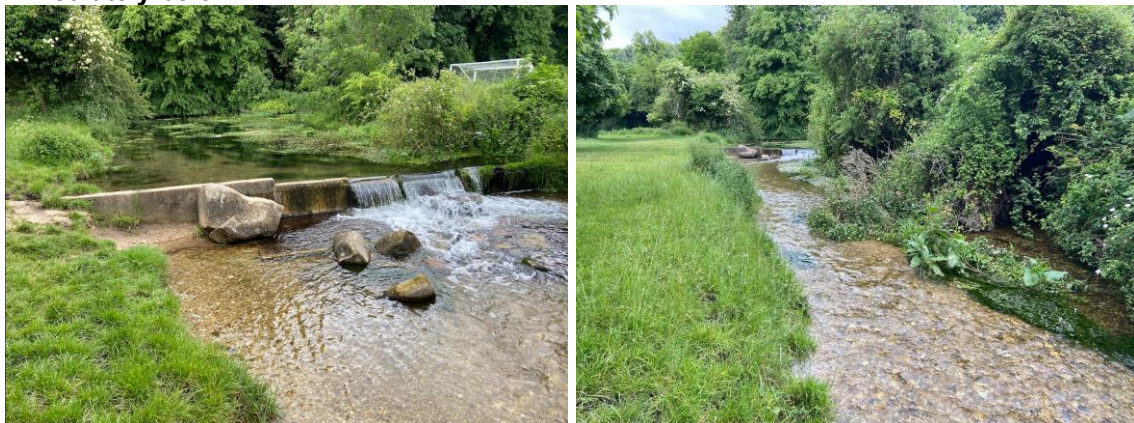
Figure 13 – Images of Weir B that creates the large lake and the elongated riffle that sits immediately below.

Weir B is approximately 8m in width and most of the drop is managed in a single step. There is a large concrete slab at the base of the fall which is at a slight down-sloping angle and there is rubble at the downstream edge of this to reduce the impact of the fall on the immediate channel bed.

Several large boulders may originally have been placed to further absorb the energy of the fall, but these are having minimal effect today.

Weir B could be removed entirely, but it may be preferable to remove just 50% of the structure, again down to the channel bed. If the wing walls are retained the top layer of these should also be removed both as a safety precaution and to reduce its presence in the area.

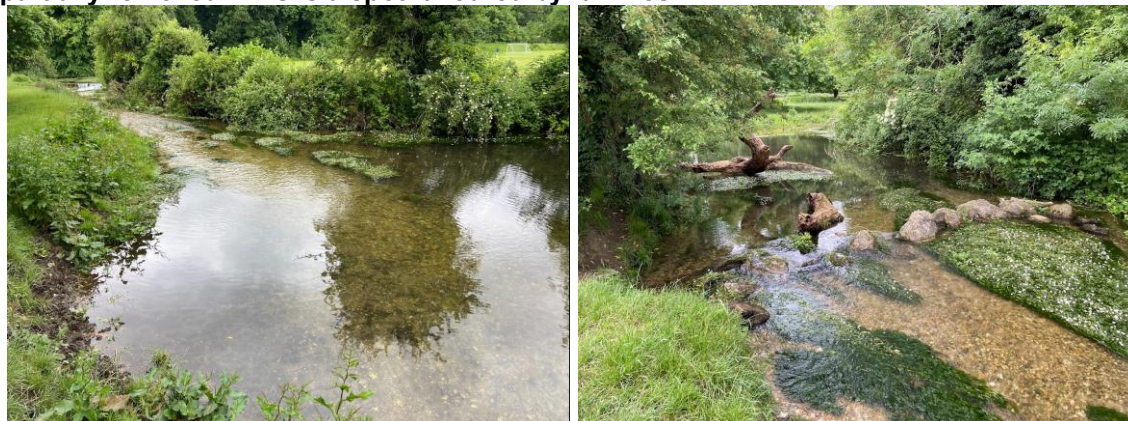
Figure 14 – The channel feeds into a smaller pool created by Weir C which has been partially removed. This is a spot favoured by families

The riffle ends at pool which is on the line of the possible paleochannel. The pool is an overwide, enlarged meander where the channel is forced to make an unnaturally sharp 90 degree left turn. The channel has been deepened and the bank erosion exacerbated by it being a favoured spot for families to picnic and paddle.

And due to the loose nature of the structure some water is able to outflank both sides of Weir C, encouraging lateral erosion.

As Weir C is not causing any significant impoundment, this could be retained as present. As it is close to the new beach and will be popular with families, the right bank should be sculpted to a shallow batter which will improve access and reduce erosion. In this lower section, some tree management should be undertaken to balance the light levels in the channel and maintain tree health.

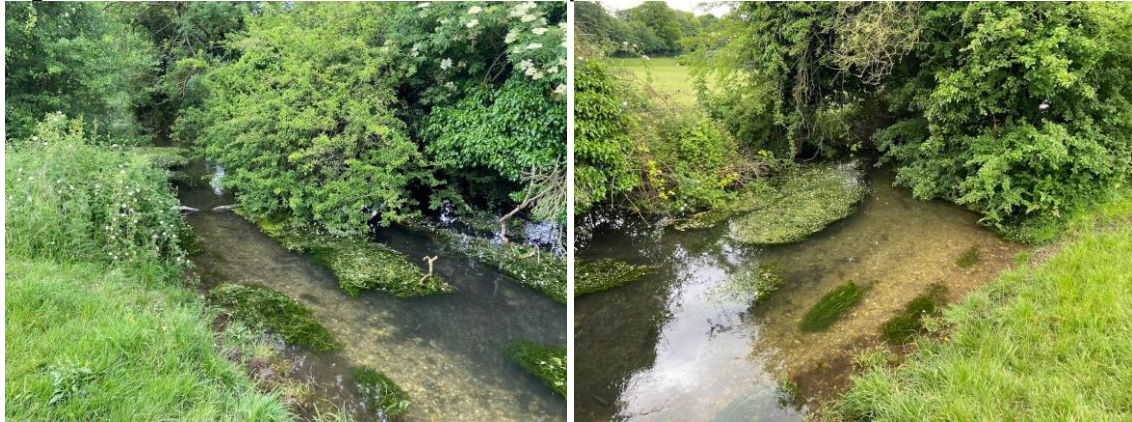
Figure 15 – In-channel variation in the lower part of section 3

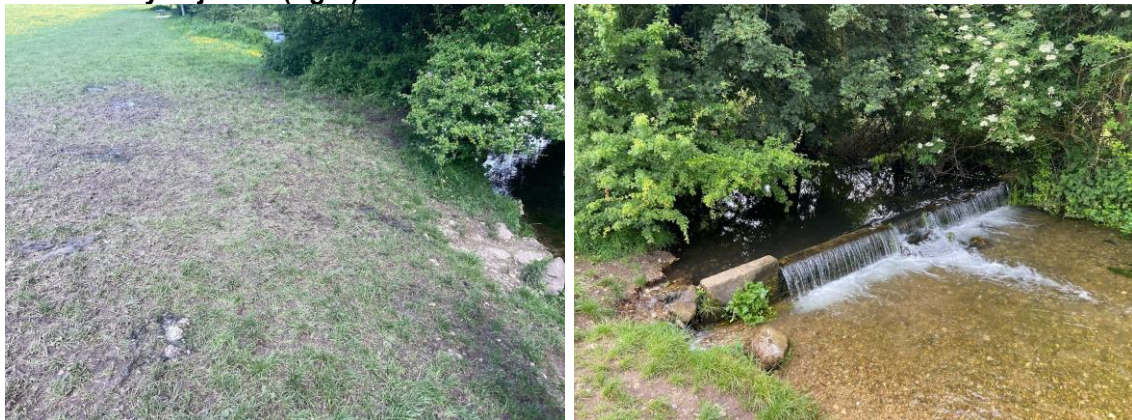
Weir D is 40m below Weir C. It is of concrete construction, 8m wide with wing walls of 0.5m height. The 5m central span has a drop of 0.4m over which water will flow during normal flow conditions. A central slot of 1m width and 0.2m height has been cut to accommodate low flows and to act as a fish easement.

With ground compression and erosion adjacent to the weir the right bank now gets outflanked by water flows and this has caused erosion of material that has exposed the whole wing wall.

Figure 16 - Images showing poaching caused by stock (left), and Weir D which is immediately adjacent (right)

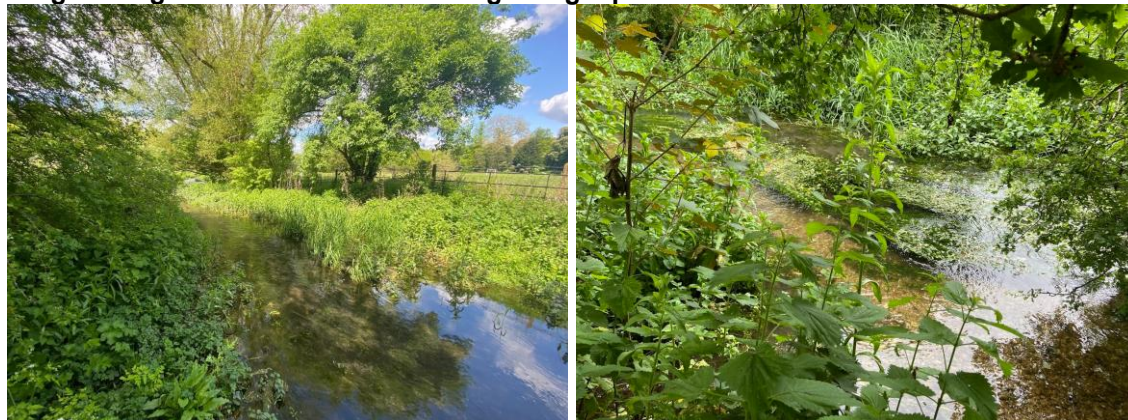
Figure 17 – Views of the channel within the nature reserve, showing the increase in marginal vegetation from the reduced grazing input

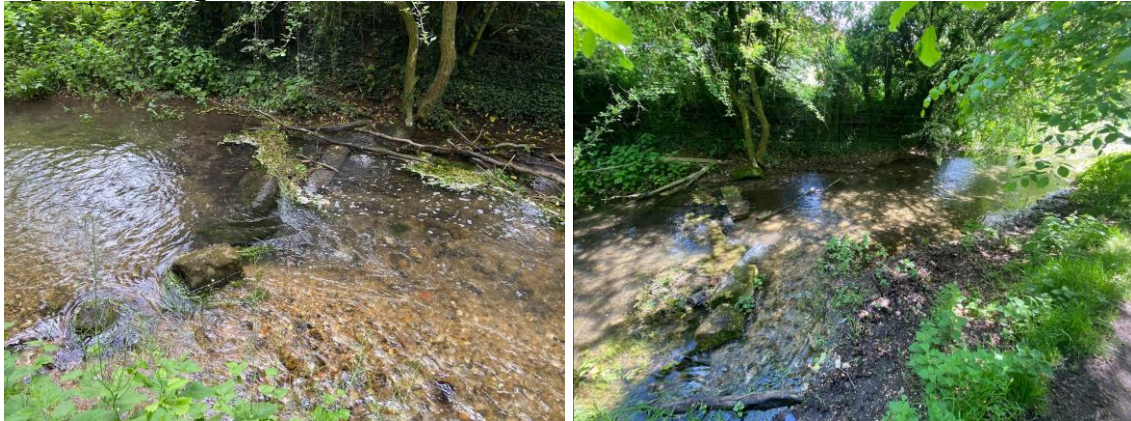
The remains of Weir E can be seen as a collection of loose rocks and concrete lumps in the channel. Without any formal structure, and being outflanked on the right bank, Weir E is not causing any appreciable impoundment and it is the only weir without a noticeable pool.

Figure 18 - Images of the remains of Weir E

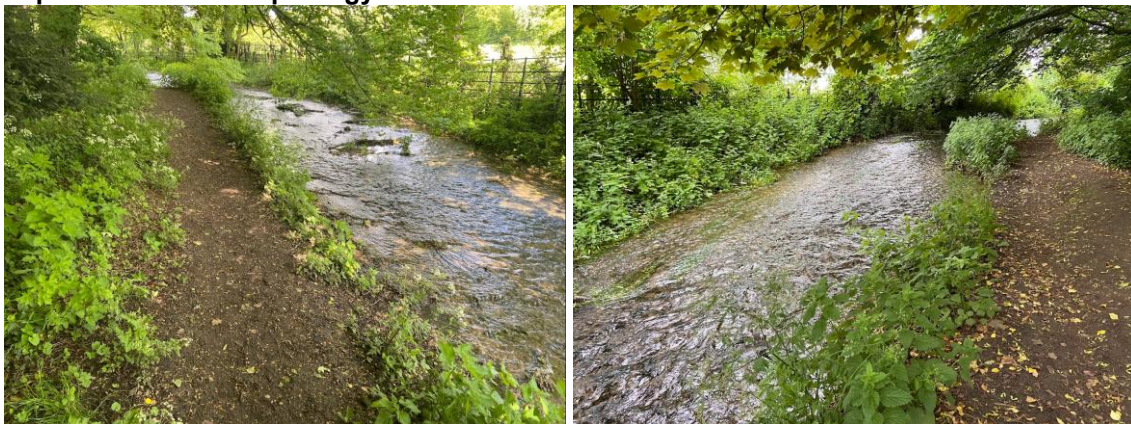
Figure 19 – The proximity of the path to the channel reduces the marginal vegetation and impacts channel morphology.

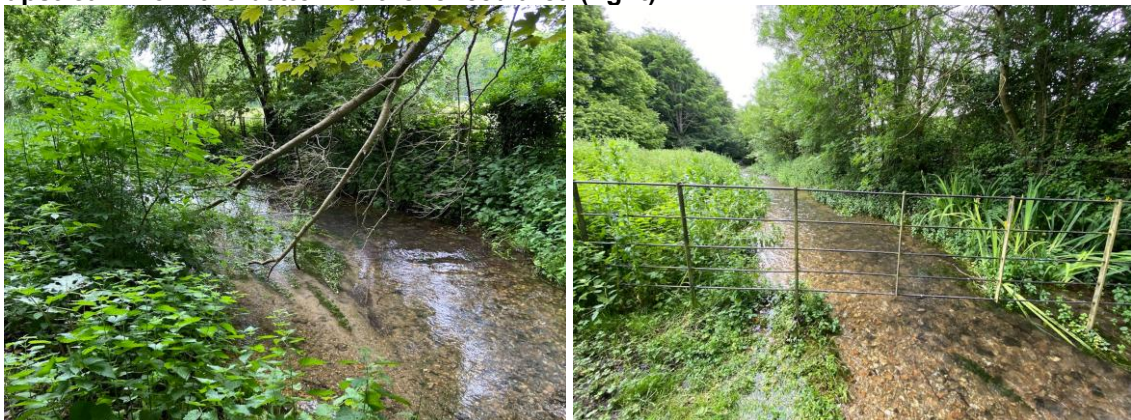
At the downstream end of the section, with few trees and where the path has already pulled back from the channel, a dense growth of marginal vegetation flourishes, even encroaching into the channel. This is evident on both banks but is particularly prominent on the right bank. This comes to an abrupt end when fencing indicates that full access to the channel has returned.

Figure 20 - Channel variation will increase where it is left alone (left), and looking upstream from the bottom of the fenced area (right)

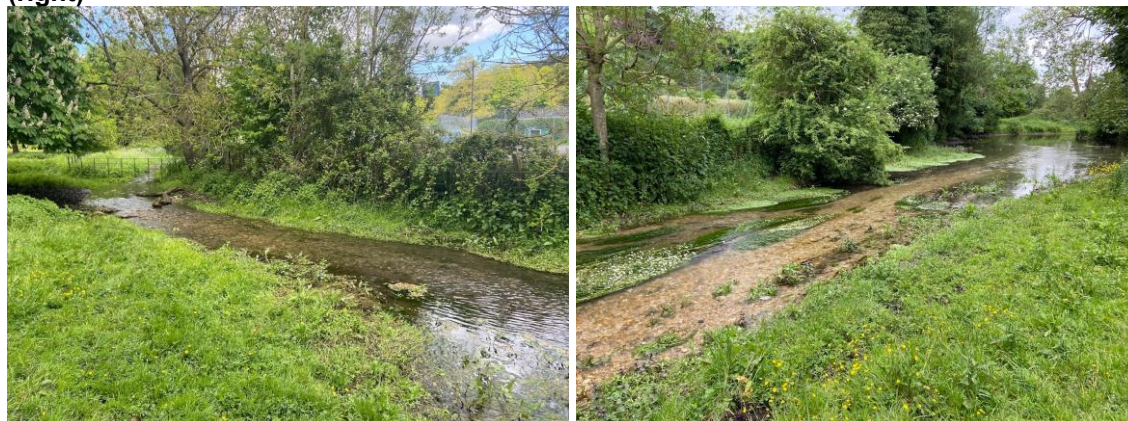
Figure 21 - Above the island pool, looking upstream (left) and downstream towards it (right)

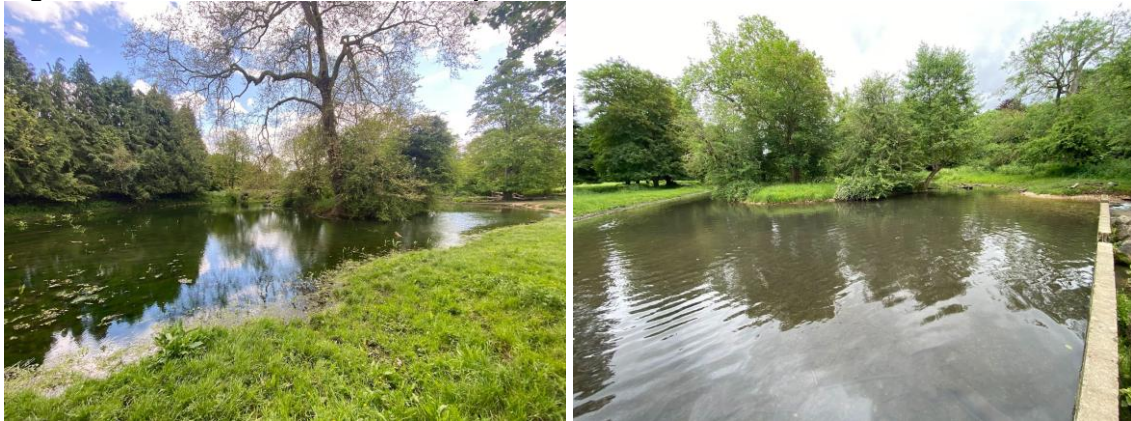
The weir pool is up to 70m in length and 30m wide. The island, already present on the 1846 estate map, is horse-shoe shaped and covered with trees and shrubs. Trees also provide shading along the entire left bank and for about half of the right bank, the remainder of which is short grass.

Figure 22 - Views of the island in the pond above Weir F

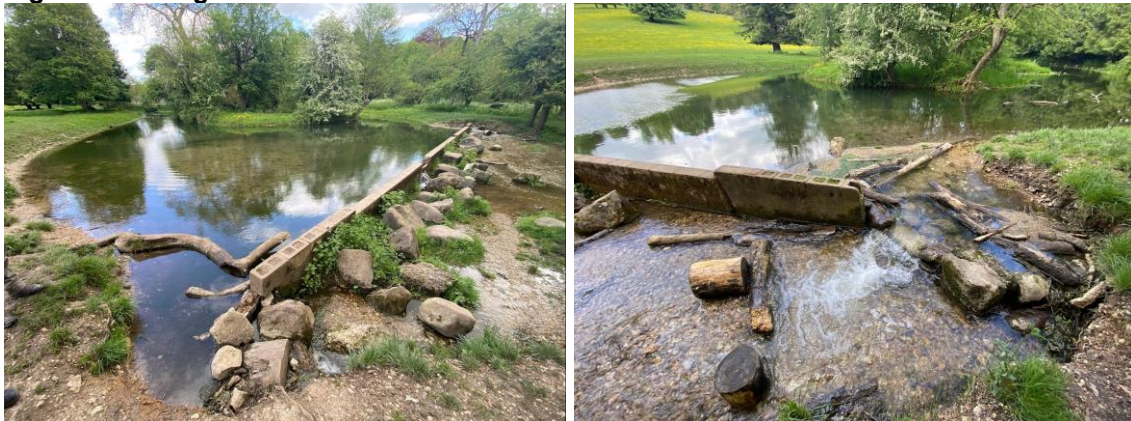
The weir is of concrete construction, and is primarily formed from three 6m sections separated by 0.5m wide notches which provide a drop of 0.3m. The walls on either end have been built up to try and keep preferential flows in the middle of the weir and these sit 0.5m above the channel bed.

Heavy erosion from people, dogs and stock has caused the weir to be significantly outflanked on both ends, and now very little flow is passing through either of the two central notches.

Figure 23 - Images of Weir F. Note that water outflanks the weir at both ends

To preserve the current benefits provided by Weir F, the plan is to retain the pool as an off-line feature by creating a causeway that routes the stream along the current left bank and past the left flank of the weir. It would then join with a newly created lowered path of preferential flow through the shallow gravel at the base of the weir which continues to the downstream boundary of the site. By re-grading the new channel from the top of the pool all the way to the boundary, it should be possible to create a channel that is passable by fish. If needed a couple of shallow steps could be included in the design.

The causeway could be created using material that has been deposited in the weir pool, or by re-grading the left bank. It would need to be approximately 70m in length with an opening at the top end to allow some water into the pool to maintain levels. The opening should be naturally armoured to ensure that the channel doesn't revert to going through the pool all the time. At the downstream end, the causeway could be tied into the left side of the weir which would help address the flanking flows that take place at present.

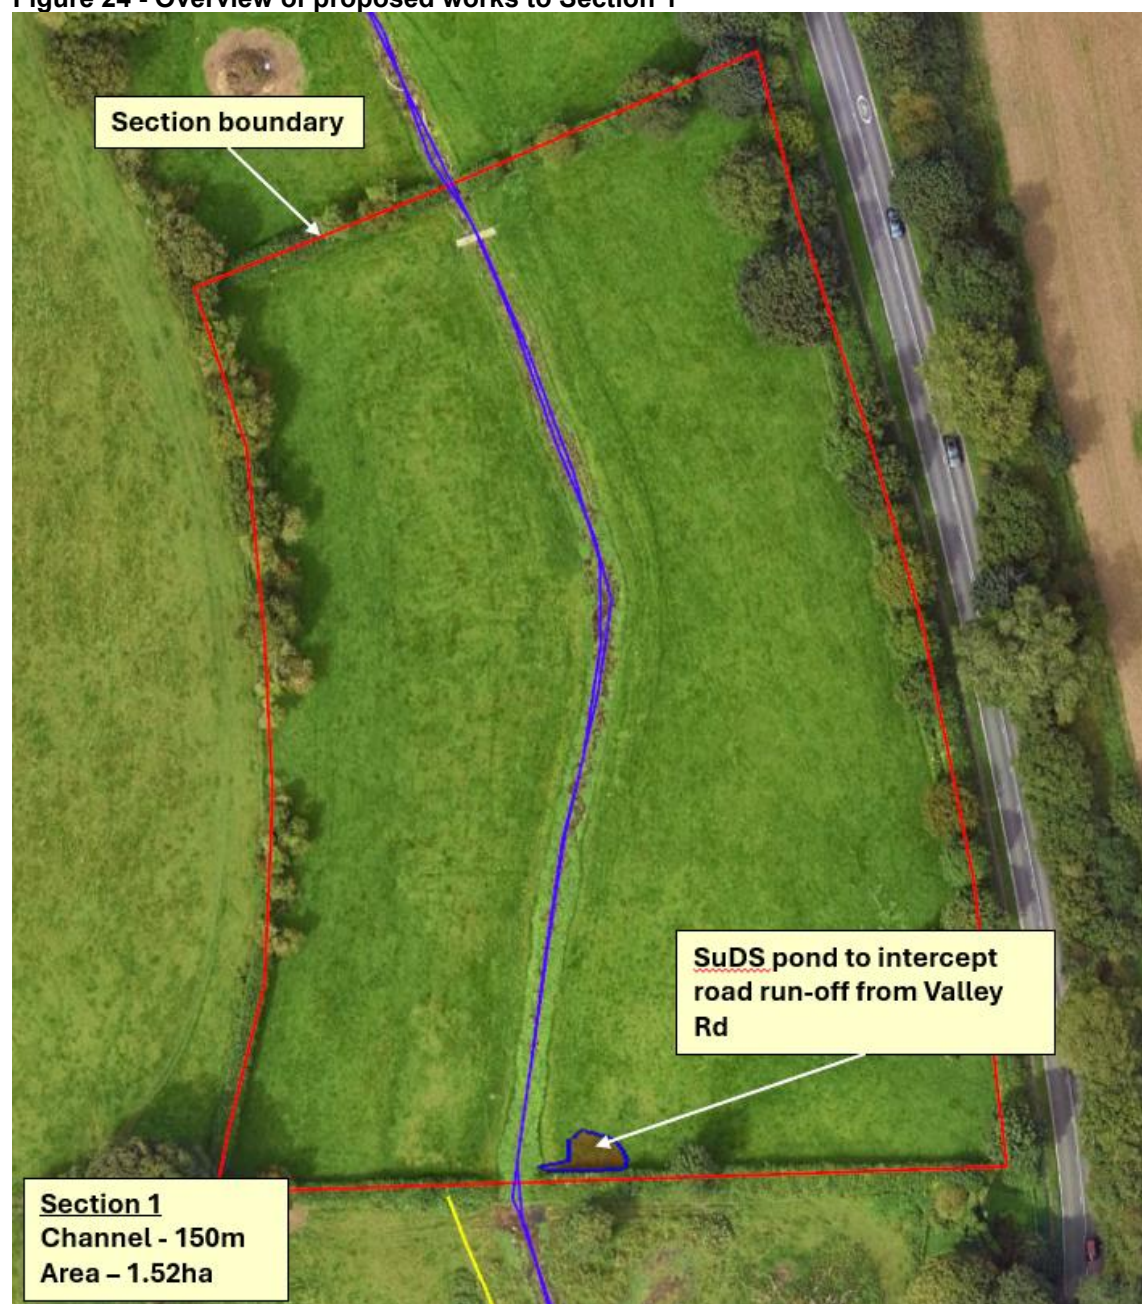
Figure 24 - Overview of proposed works to Section 1

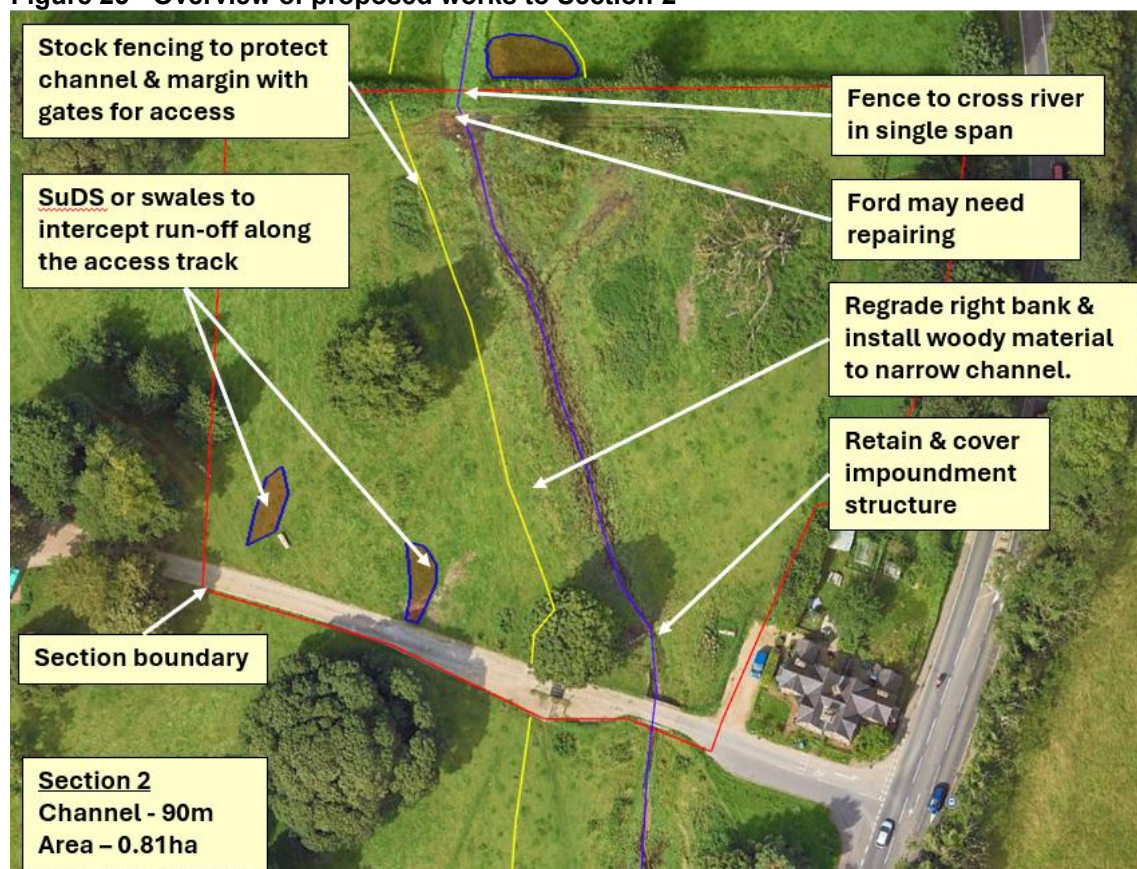
Some repair of the ford may be required to reduce the sediment input to the channel by cattle and vehicles crossing, but this may be obviated by the reduced access by grazing animals.

Figure 25 - Overview of proposed works to Section 2

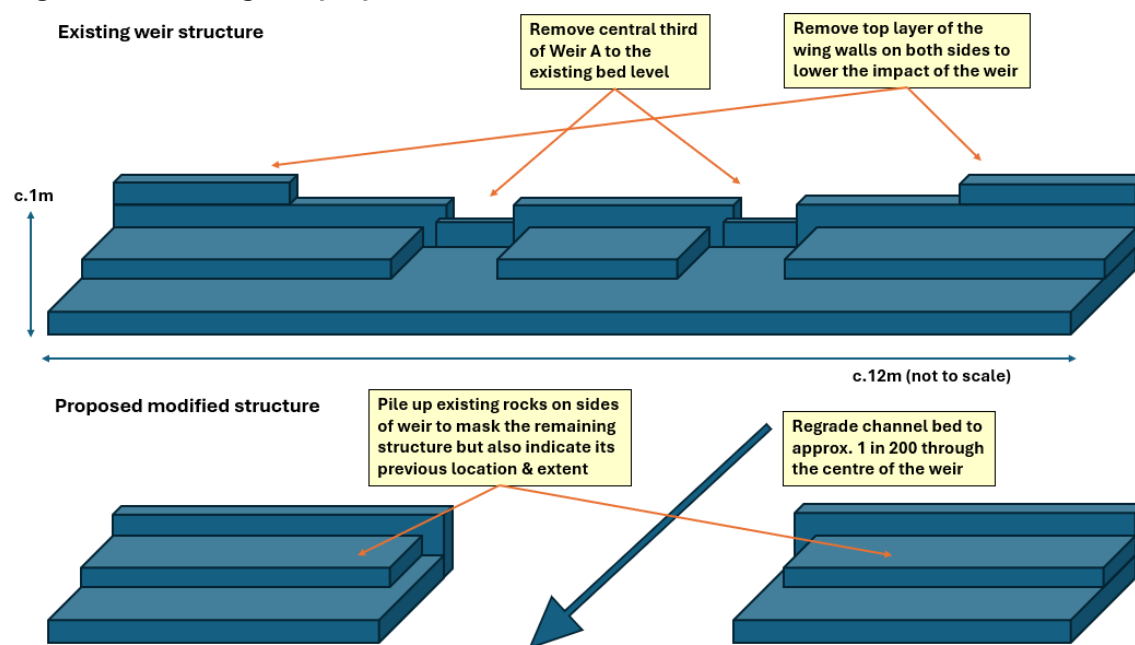
The intention is to remove the impoundment caused by the weirs in this section, whilst retaining some of the history that they represent.

Figure 26 - Existing and proposed modifications to Weir A

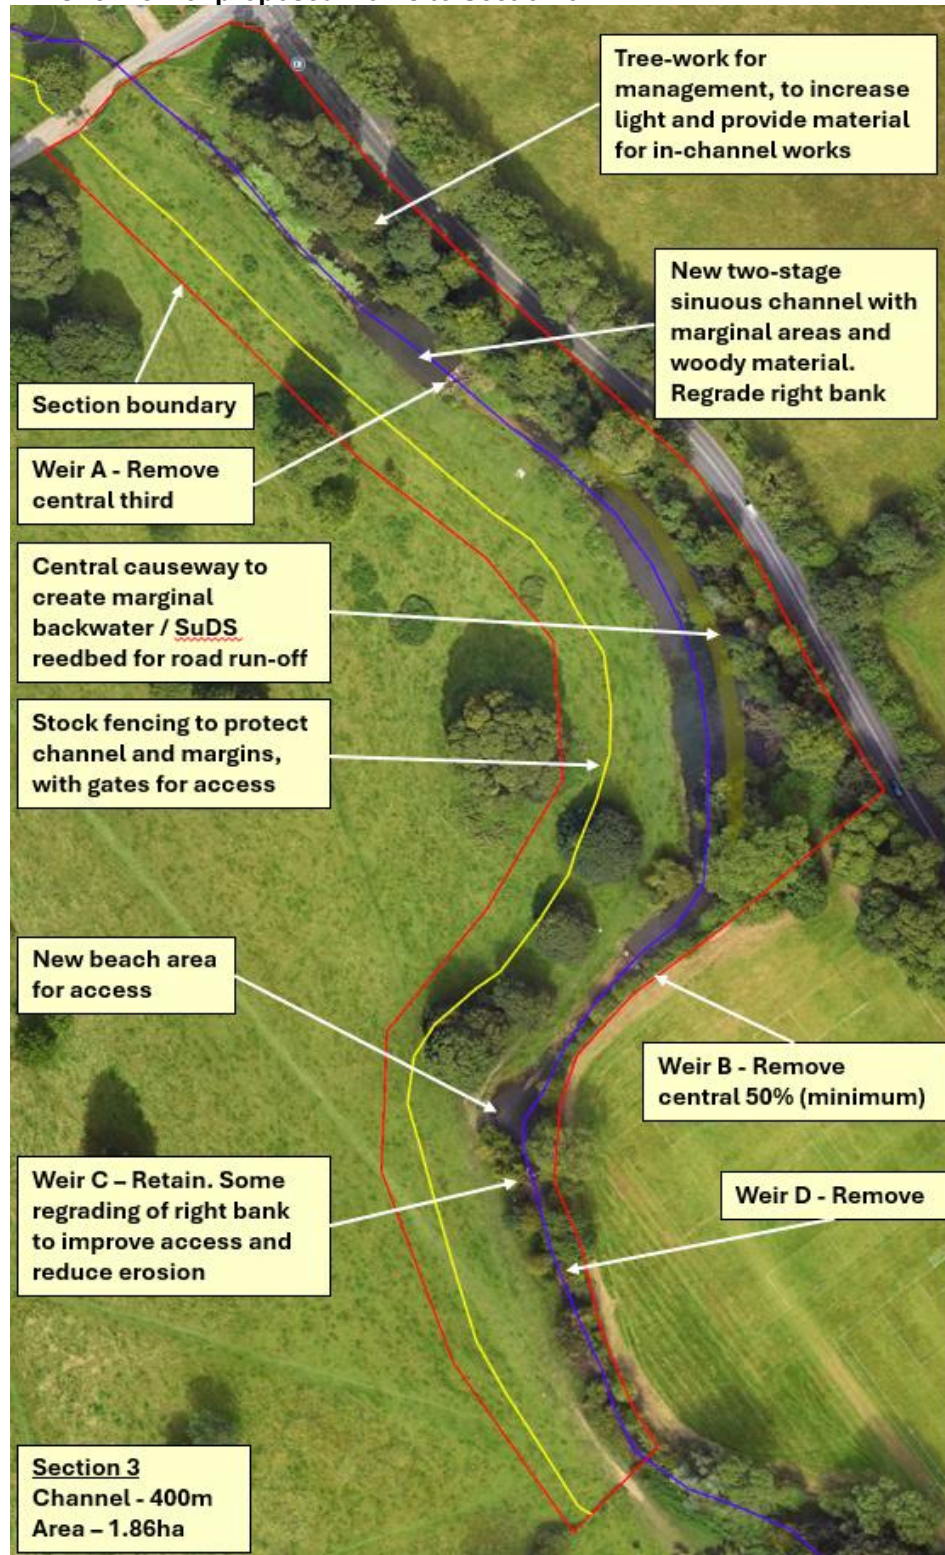
Material from the existing right bank can be re-graded to help narrow the channel from one-side and create its shape, reduce appearance of the embankment, and possibly to provide material for the new causeway. The sediment that has accumulated in the weir pools could also be used.

Figure 27 - Overview of proposed works to Section 3

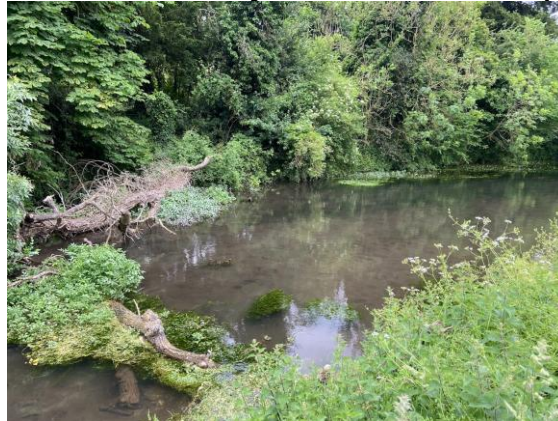
A causeway should be created in the pool above Weir B. This should form the left bank of the new channel, and be connected to it at the downstream end. The backwater behind the causeway will trap sediment and run-off coming from the drains on Valley Road to the east, but also act as a temporary pond in times of high water. The habitat of the backwater could be improved through felling of two or three trees directly into it, and additional management of the trees on the left bank will provide material for other parts of the site.

Figure 28 - Location of the causeway and backwater in the pool above Weir B

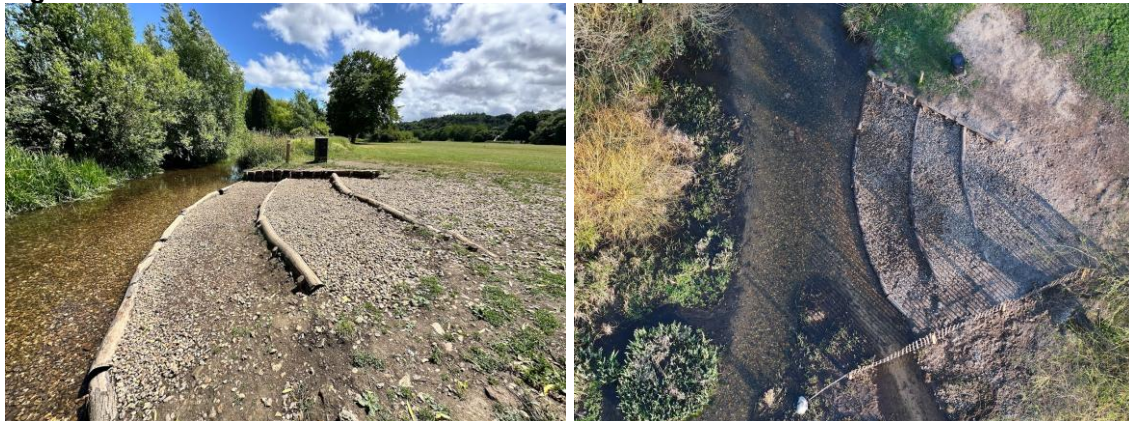
At the pool below Weir B, popular with families, the bank needs to be re-graded to re-shape the corner and narrow the channel. To protect the bank from further erosion and to facilitate access by families, a new beach should be installed. It should be approximately 5m in width and be topped with angular flint gravel, with transverse wooden struts to reduce downslope migration of material. The bank should be sculpted to ensure a beach slope of 17% or less.

Figure 29 - Views of a beach structure as an example of what could be installed

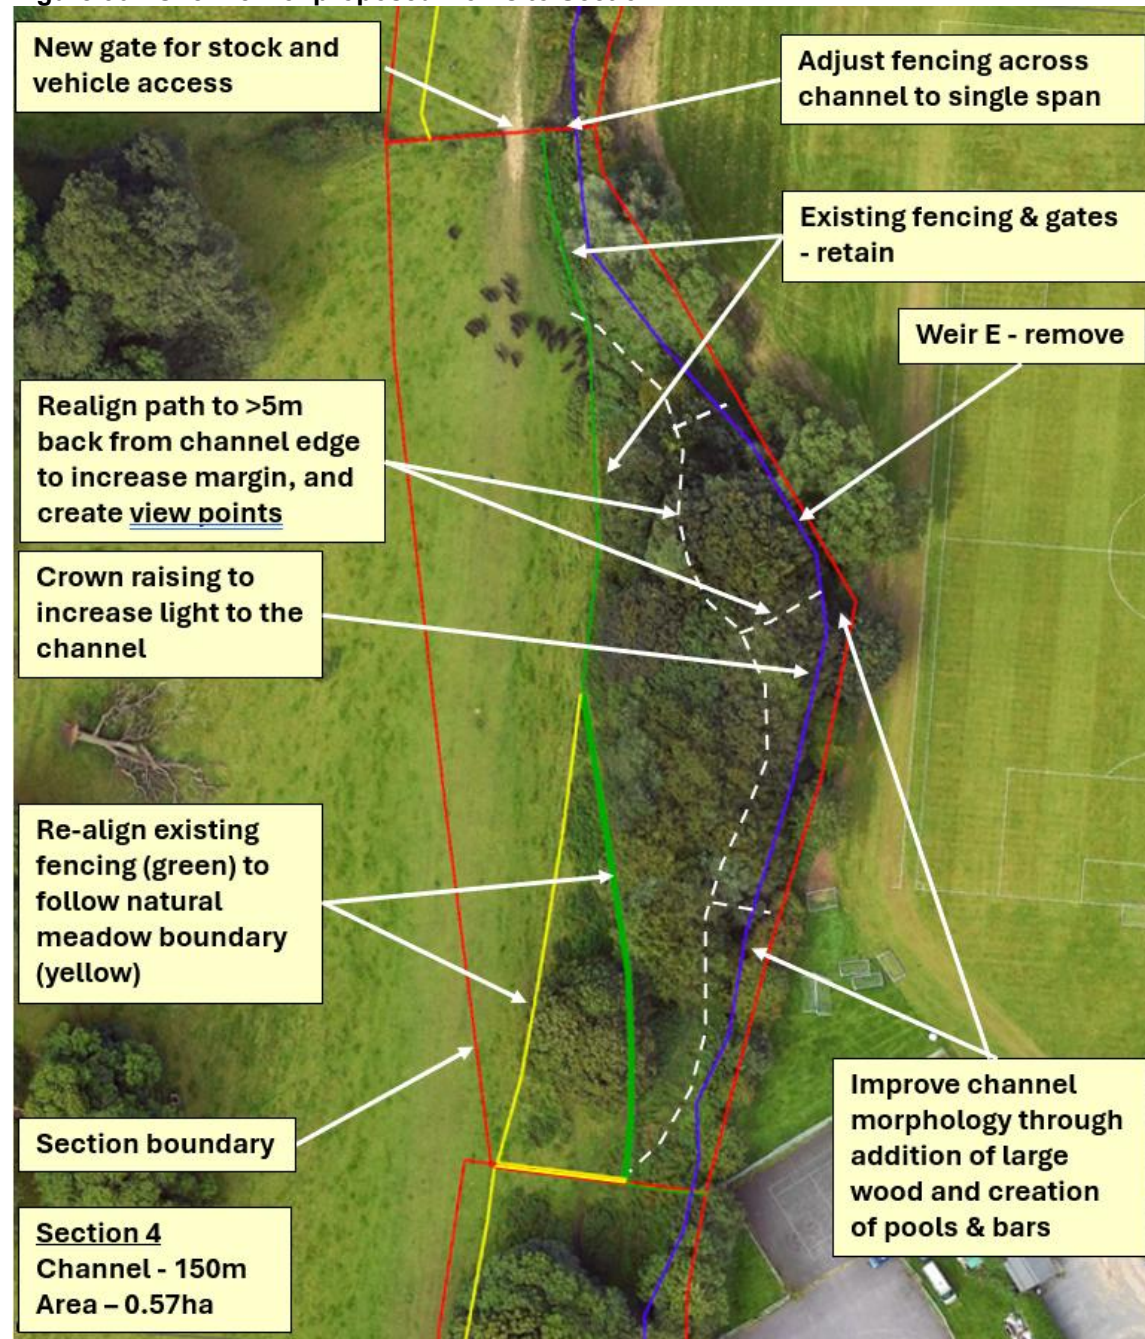
Figure 30 - Overview of proposed works to Section 4

The lower 65m of existing estate fencing should be realigned to match the natural boundary between the meadow and the tree cover and to improve the tie-in with the fencing in Section 5. A new 16m length may be required to tie the realigned fence into the existing channel spur at the down stream end of the nature reserve.
