CHILTERN
CHALK STREAMS
PROJECT

Invitation to Tender

Scheme: River habitat restoration & barrier removal works to 1km of the Hughenden stream at Hughenden Manor

Works: **Design & build of river habitat improvement of the Hughenden stream at Hughenden Manor**

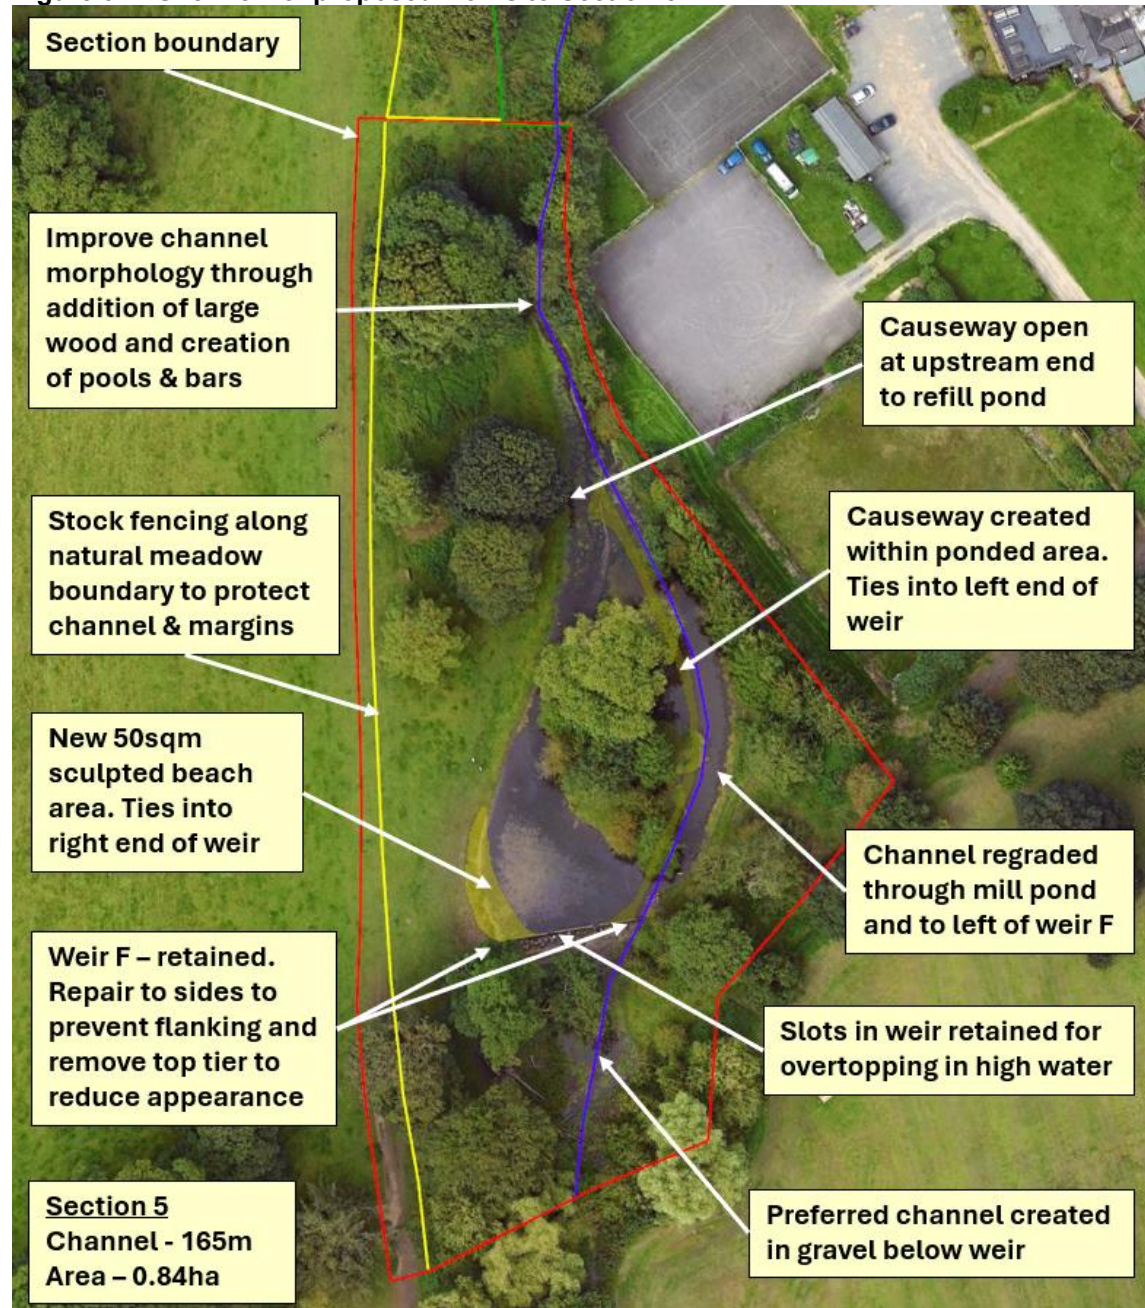
To preserve the current benefits provided by Weir F, the plan is to retain the pool as an off-line feature by creating a causeway that routes the stream along the current left bank and past the left flank of the weir. It would then join with a newly created lowered path of preferential flow through the shallow gravel at the base of the weir which continues to the downstream boundary of the site. By re-grading the new channel from the top of the pool all the way to the boundary, it should be possible to create a channel that is passable by fish. If needed a couple of shallow steps could be included in the design.

The causeway could be created using material that has been deposited in the weir pool, or by re-grading the left bank. It would need to be approximately 70m in length with an opening at the top end to allow some water into the pool to maintain levels. The opening should be naturally armoured to ensure that the channel doesn't revert to going through the pool all the time. At the downstream end, the causeway could be tied into the left side of the weir which would help address the flanking flows that take place at present.

Figure 31 - Overview of proposed works to Section 5

To protect the pool and marginal areas from cattle poaching, 170m of stock fencing is required along the boundary of the meadow. This should tie into the hedgerow at the southern boundary of the site and will need two pedestrian gates installed to permit access.

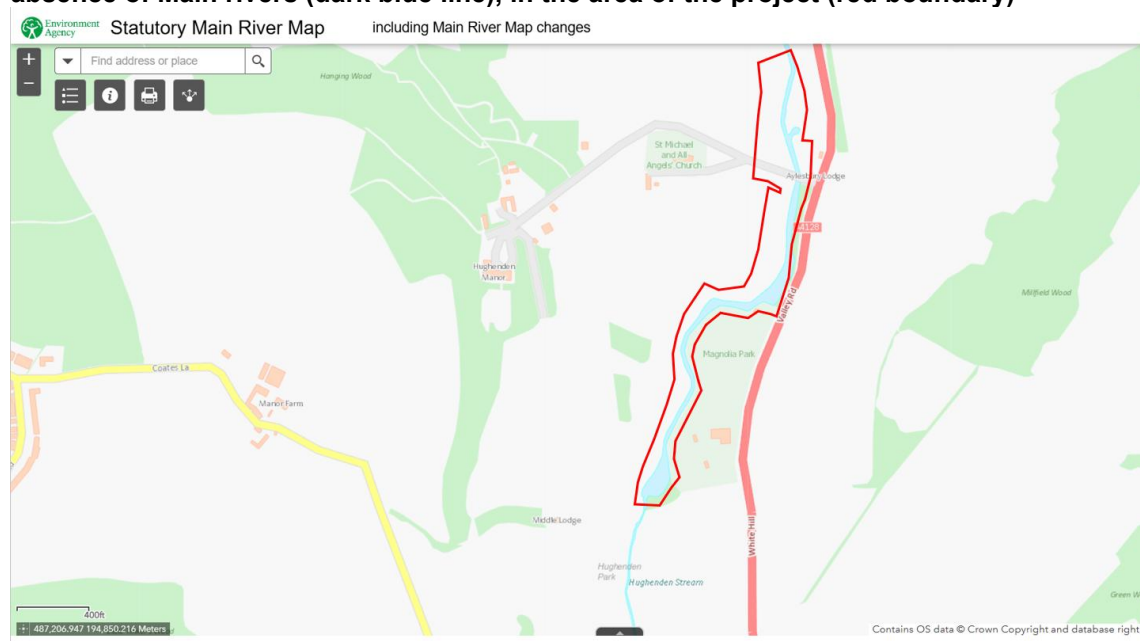
Figure 32 - Map showing the presence of Ordinary watercourses (pale blue line) and absence of Main rivers (dark blue line), in the area of the project (red boundary)

The Hughenden stream through Hughenden Manor is a designated Ordinary Water Course for which Buckinghamshire Council are the Lead Local Flood Authority (LLFA). See fig. 33. Flood risk for the site is shown in fig. 34.

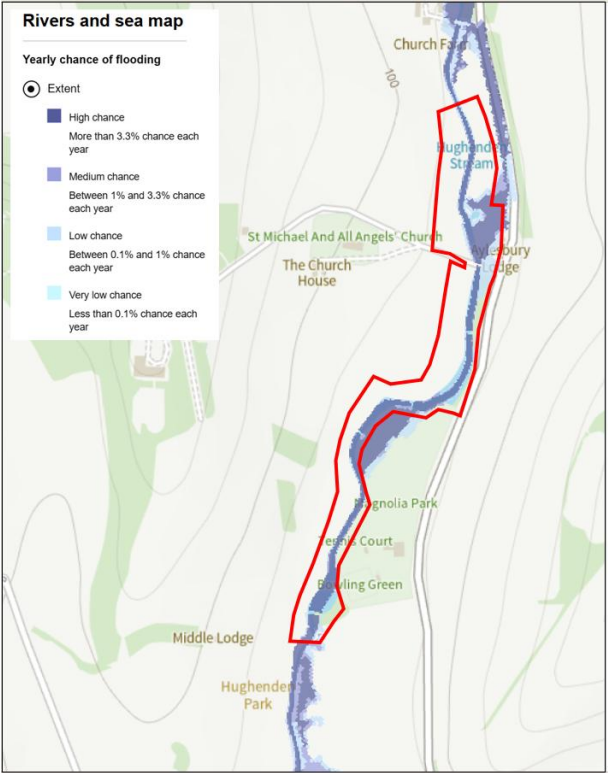
Figure 33 - Map showing the flood risk of the project site (from <https://check-long-term-flood-risk.service.gov.uk>)

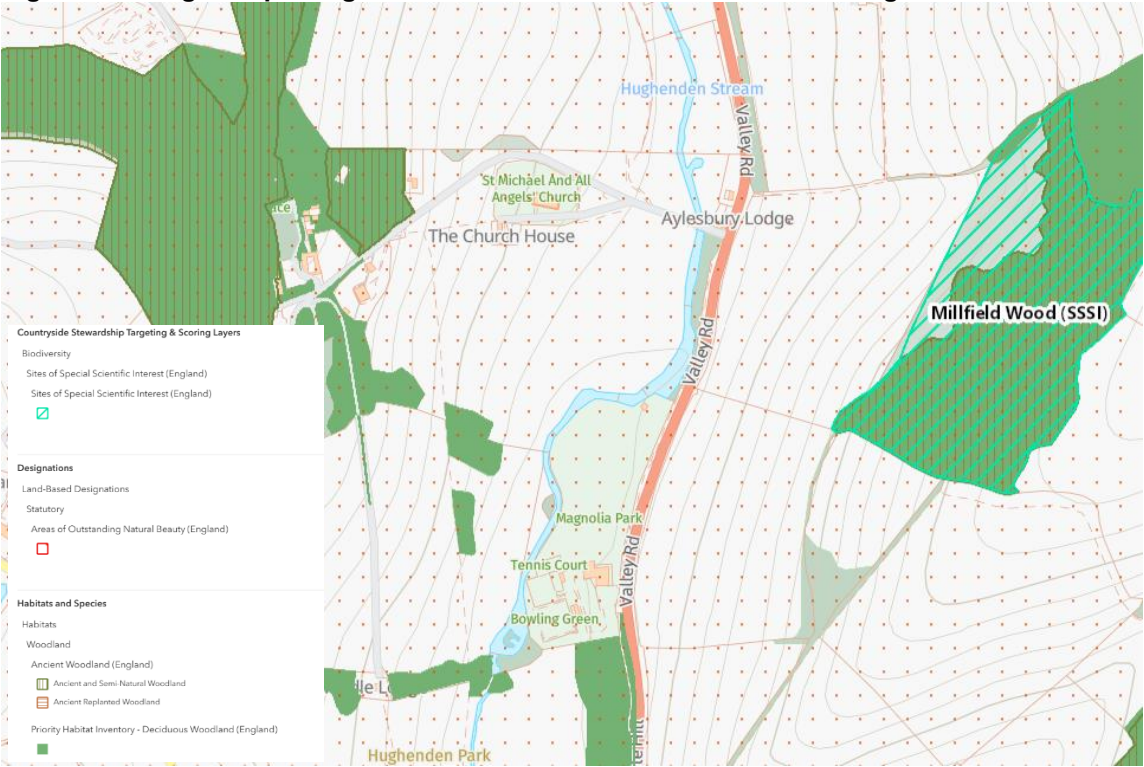
Figure 34 - Magic Map designations for the works site and surrounding area

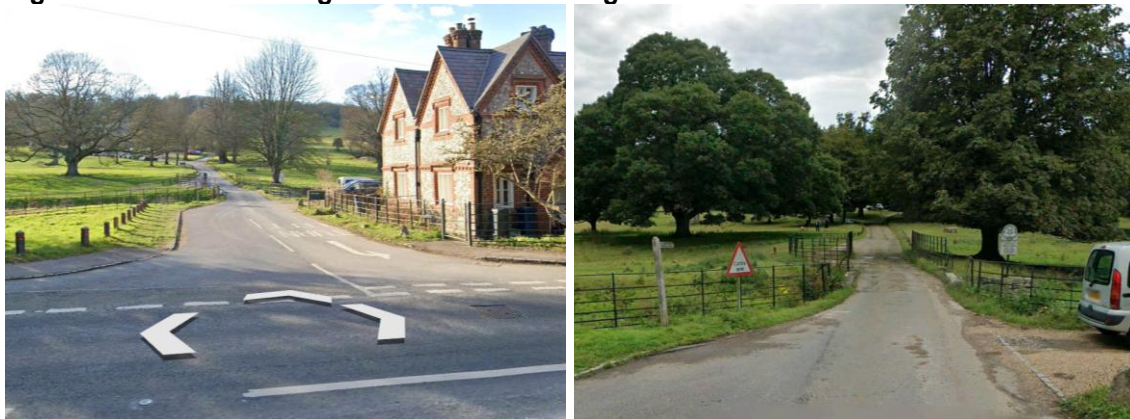
Access to Hughenden Manor is via signed road off Valley Rd at SU 86646 95486. There is a stone bridge after 30m. For both the road and the bridge, the conditions and suitability for plant should be assessed before use to minimise damage that may be caused.

Figure 35 - Access to Hughenden Manor © Google Earth

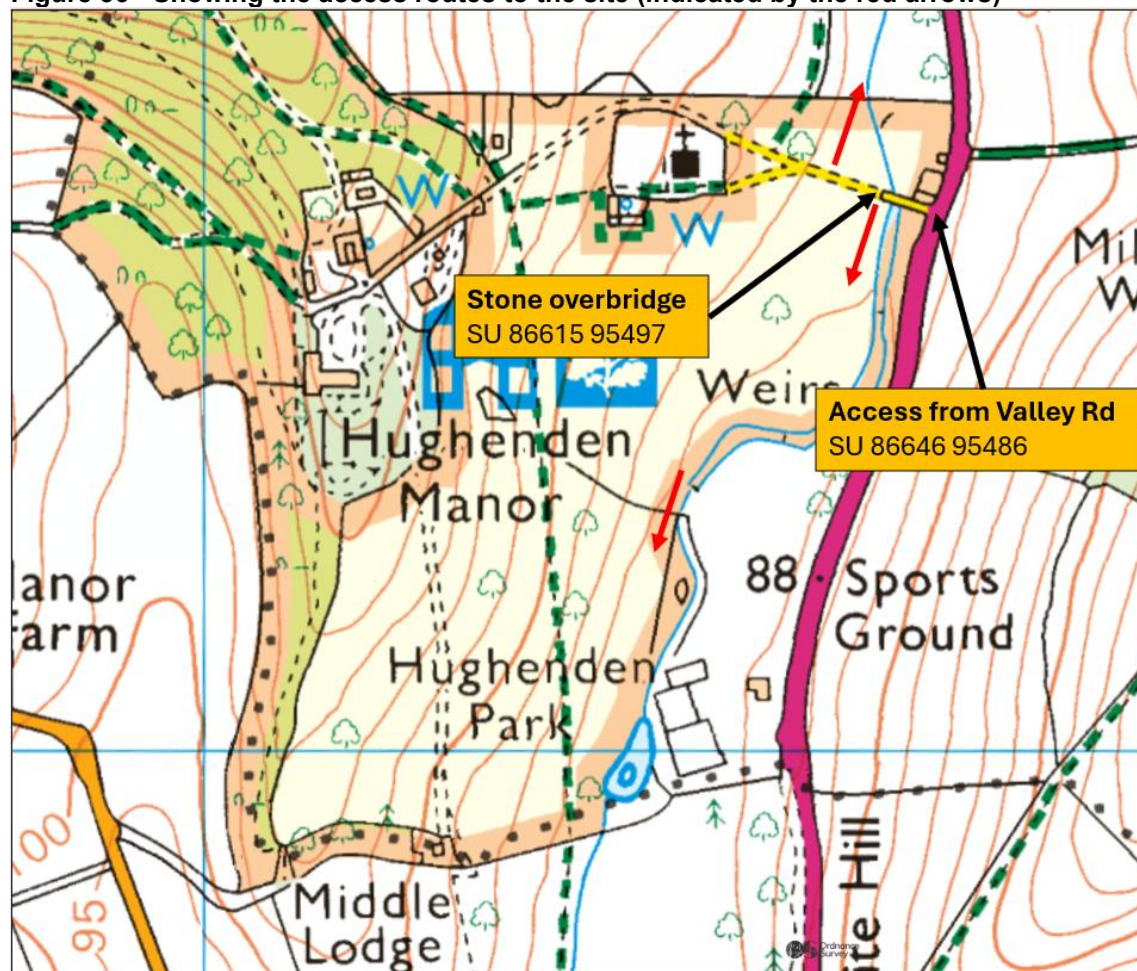
Figure 36 - Showing the access routes to the site (indicated by the red arrows)
